Alternative fencing materials for blackwood swamp coupes

S.M. Jennings
Forestry Tasmania, PO Box 63, Smithton 7330

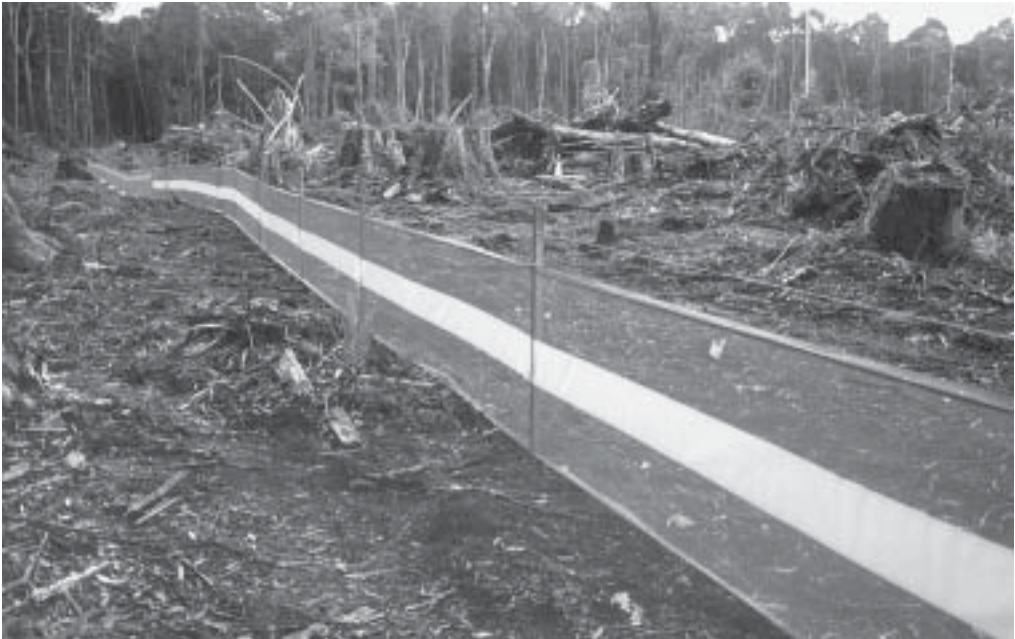
Photo 1. A section of onion bag mesh attached to top and bottom wires.

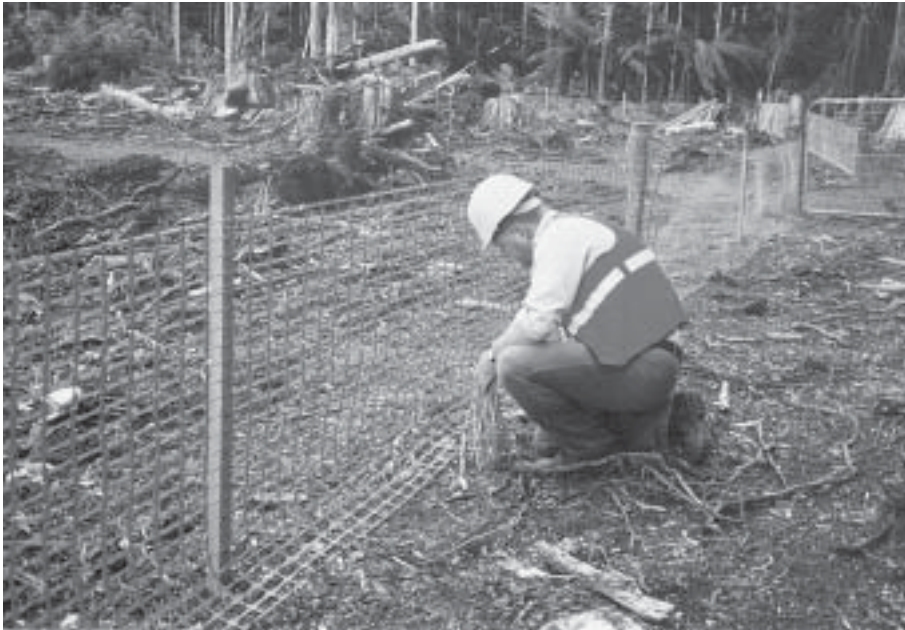
Photo 2. Pegging down the bottom of the barrier mesh.

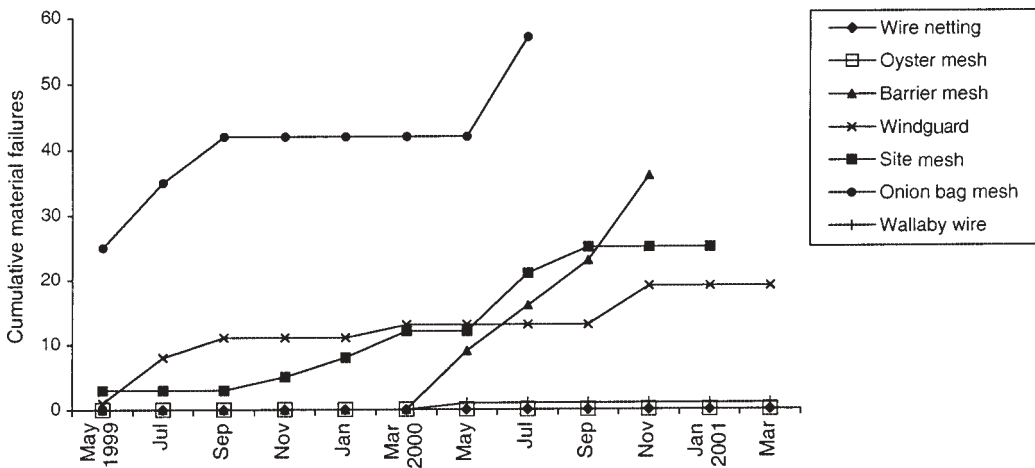
Figure 1. Cumulative material failures over 100 m of each material tested.

There were 137 cases of material failure noted. The failures by material type over two years are presented in Figure 1. However, if the effectiveness of any of the materials became severely compromised

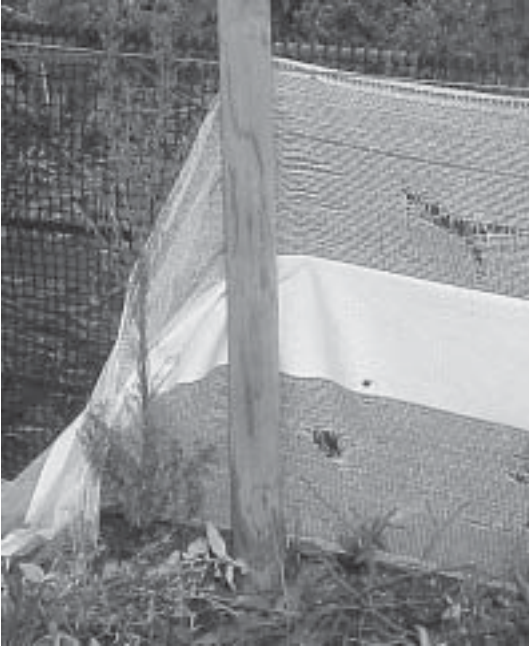
Photo 3 (top). Onion bag mesh soon lost its colour and disintegrated.

The colour of the red and white onion bag mesh faded very quickly and was followed by rapid disintegration of the material itself (Photo 3). The first section of onion bag mesh was replaced within six months, with complete replacement required after 15 months.

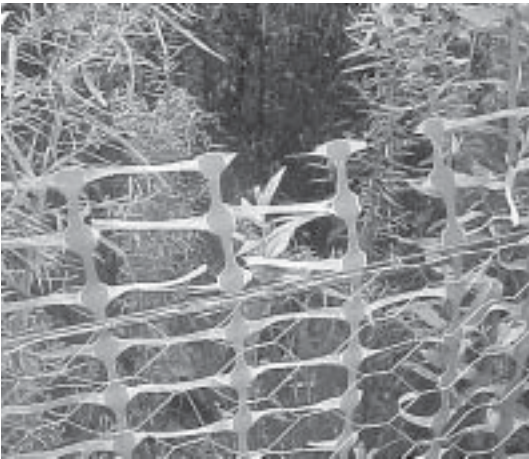
Photo 4 (centre). Barrier mesh became brittle with exposure to sunlight.

The orange barrier mesh showed great promise with no failures during the first year. However, it was not UV-stabilised and became very brittle (Photo 4). The incidence of failure increased rapidly after the first summer, leading to complete disintegration of the material within 19 months.

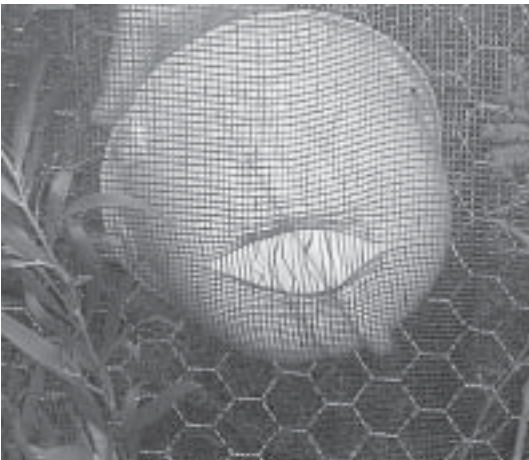
Photo 5 (bottom). Animal damage to 'windguard' material.

The black windguard material was severely tested within the first few months and sustained small areas of damage as animals tried to claw their way through this softer fabric. However, the weave of the material did not allow large holes to develop and the integrity of the fence was retained (Photo 5). This material was UV-stabilised and did not show any greater levels of damage with time. The windguard material did not require replacing during the two-year monitoring period. Infrequent visits since have shown that it is still intact after two-and-a-half years.

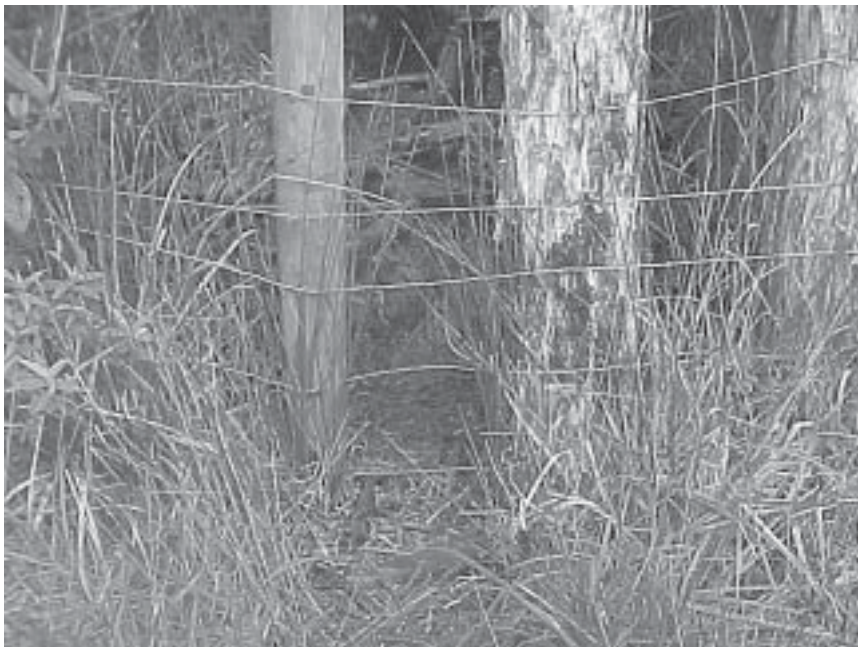
Photo 6. A wallaby run developed through the larger squares of the tree-damaged wallaby wire fence.

The section of hinge-joint wallaby wire was damaged by a falling sapling, which pushed the top of the fence closer to the ground. The smaller sized mesh at the bottom of the fence appeared to be small enough to exclude pademelons with no breaches identified, but a wallaby run developed through the fence where the larger top squares were closer to the ground (Photo 6).
