**SOUTHWOOD PROJECT – GEOTECHNICAL & HYDROGEOLOGICAL
INVESTIGATIONS**

HUON DISTRICT, TASMANIA

HO154/1-AG

30 August 2002

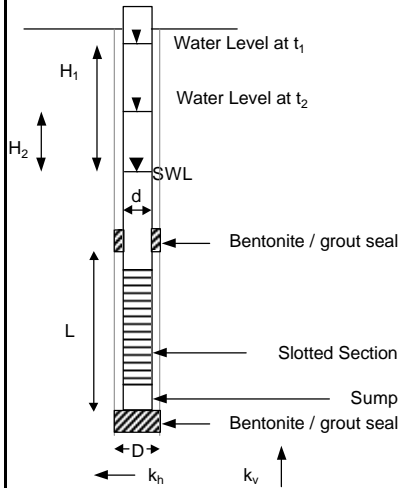
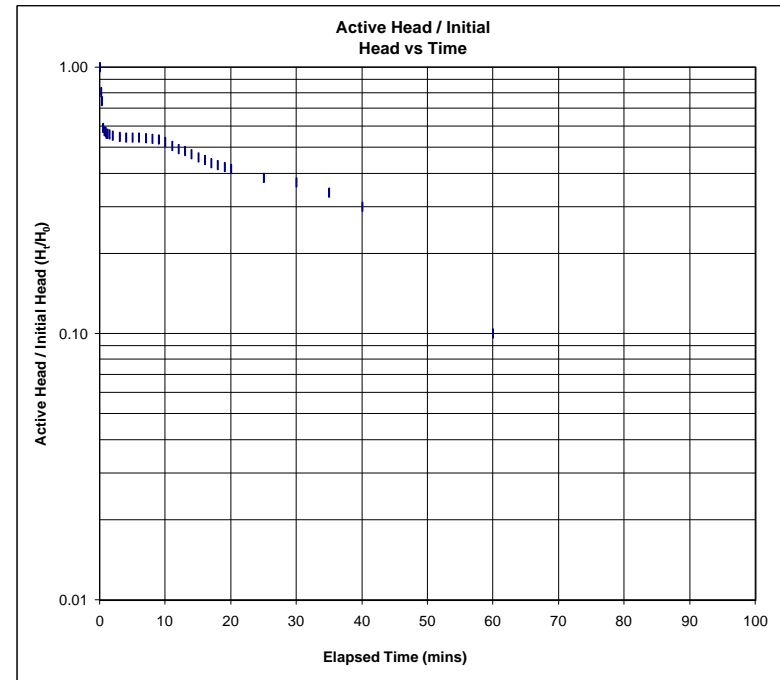
Hvorslev, 1951 - Well Point : Filter in Uniform Soil

Fixed Parameters	Unit	Value
SWL = Standing Water Level	m bGL	8.71
D = diameter of test section or ID of casing	m	0.100
d = diameter of standpipe	m	0.057
L = length of test section	m	8.71
estimated k_h/k_v	ratio	5.00
where k_v = vertical coefficient of permeability		
k_h = horizontal coefficient of permeability		
m = transformation ratio = $\sqrt{k_h/k_v}$	ratio	2.236
T = basic time lag = t when $(H_t/H_0 = 0.37)$	mins	1.1

Chosen time t_1	mins	10.0
Chosen time t_2	mins	40.0
H_1 = active Head at time t_1	m	4.56
H_2 = active Head at time t_2	m	2.60

k_h	k_v	k_{mean}	k_h	k_v	k_{mean}
$m^3/m^2/s = m/s$			$m^3/m^2/day = m/day$		
8.68E-08	1.74E-08	3.88E-08	7.50E-03	1.50E-03	3.35E-03
4.21E-06	8.43E-07	1.88E-06	3.64E-01	7.28E-02	1.63E-01

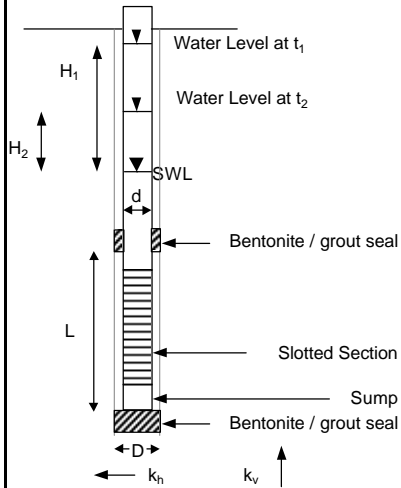
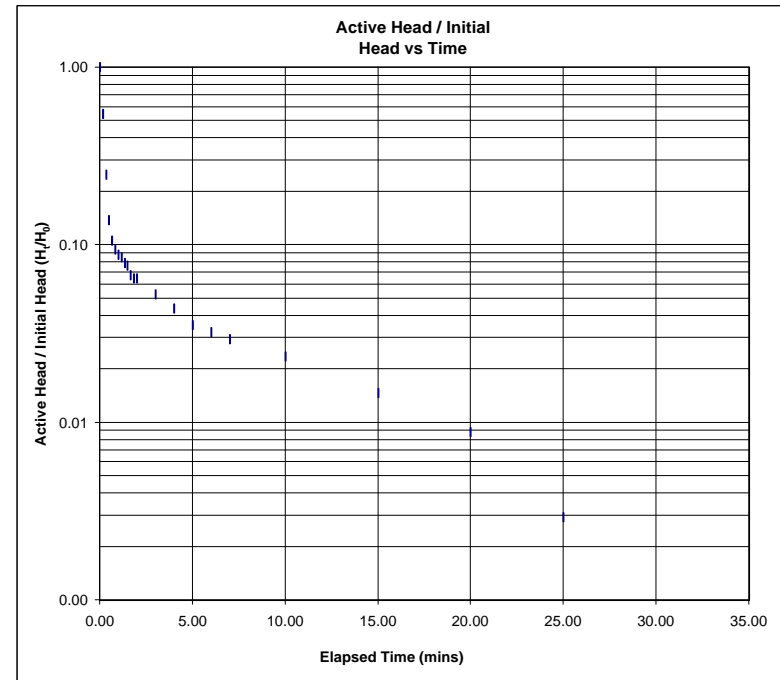
Chosen time t_1	mins	0.8
Chosen time t_2	mins	20.0
H_1 = active Head at time t_1	m	0.32
H_2 = active Head at time t_2	m	0.03

k_h	k_v	k_{mean}	k_h	k_v	k_{mean}
	$m^3/m^2/s = m/s$			$m^3/m^2/day = m/day$		
Variable Head Determination $k_h = \frac{d^2 \ln(2mL/D)}{8L} \ln(H_1/H_2)$	4.78E-07	9.57E-08	2.14E-07	4.13E-02	8.26E-03	1.85E-02
Basic Time Lag Determination $k_h = \frac{d^2 \ln(2mL/D)}{8LT}$	3.52E-06	7.04E-07	1.57E-06	3.04E-01	6.08E-02	1.36E-01

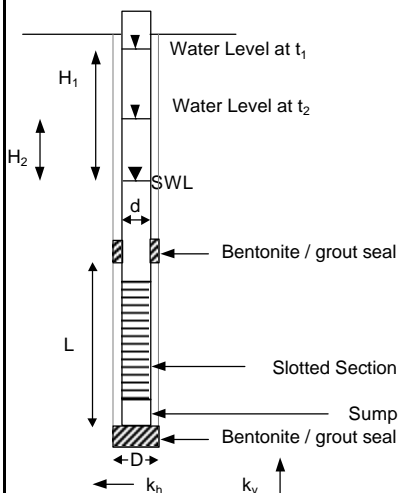
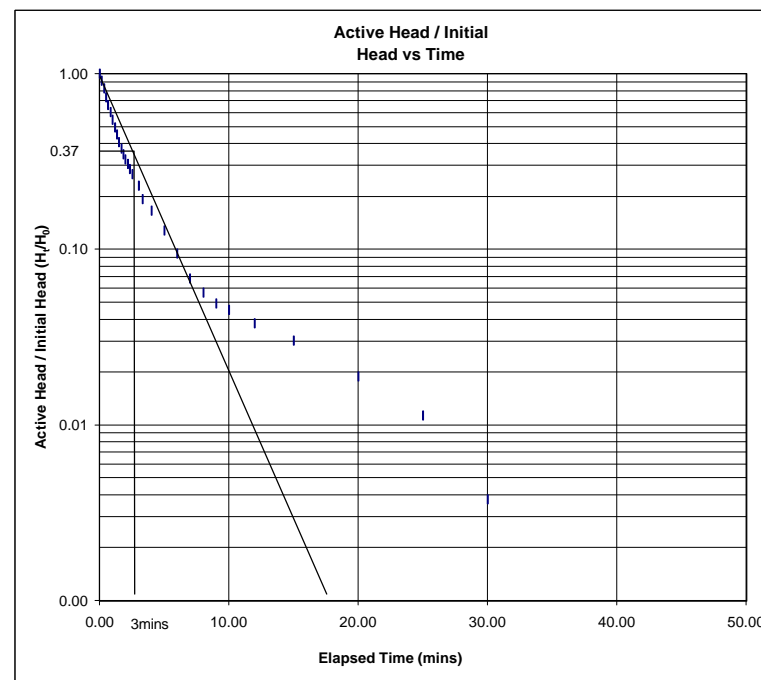
Fixed Parameters	Unit	Value
SWL = Standing Water Level	m bGL	2.99
D = diameter of test section or ID of casing	m	0.100
d = diameter of standpipe	m	0.057
L = length of test section	m	7.25
R = radius of standpipe	m	0.05
r = radius of test section	m	0.03
T = basic time lag = t when (H _t /H ₀ = 0.37)	mins	3.0
	secs	180

TEST DATA			
Elapsed Time (mins)	Depth to Water (mbGL)	Active Head (m)	Active Head/ Initial Head		
0.00	5.64	-2.65	1.00		
0.17	5.41	-2.42	0.91		
0.33	5.17	-2.18	0.82		
0.50	4.94	-1.95	0.74		
0.66	4.75	-1.76	0.66		
0.83	4.59	-1.60	0.60		
1.00	4.44	-1.45	0.55		
1.17	4.30	-1.31	0.49		
1.33	4.18	-1.19	0.45		
1.50	4.07	-1.08	0.41		
1.66	3.98	-0.99	0.37		
1.83	3.91	-0.92	0.35		
2.00	3.85	-0.86	0.32		
2.17	3.80	-0.81	0.31		
2.33	3.75	-0.76	0.29		
2.50	3.70	-0.71	0.27		
3.00	3.60	-0.61	0.23		
3.30	3.50	-0.51	0.19		
4.00	3.43	-0.44	0.17		
5.00	3.33	-0.34	0.13		
6.00	3.24	-0.25	0.09		
7.00	3.17	-0.18	0.07		
8.00	3.14	-0.15	0.06		
9.00	3.12	-0.13	0.05		
10.00	3.11	-0.12	0.05		
12.00	3.09	-0.10	0.04		
15.00	3.07	-0.08	0.03		
20.00	3.04	-0.05	0.02		
25.00	3.02	-0.03	0.01		
30.00	3.00	-0.01	0.00		
35.00	2.99	0.00	0.00

K m/s	m/day
Basic Time Lag Determination $K = \frac{r^2 \ln(L/R)}{2LT_0}$	1.5E-06	9.66E-02

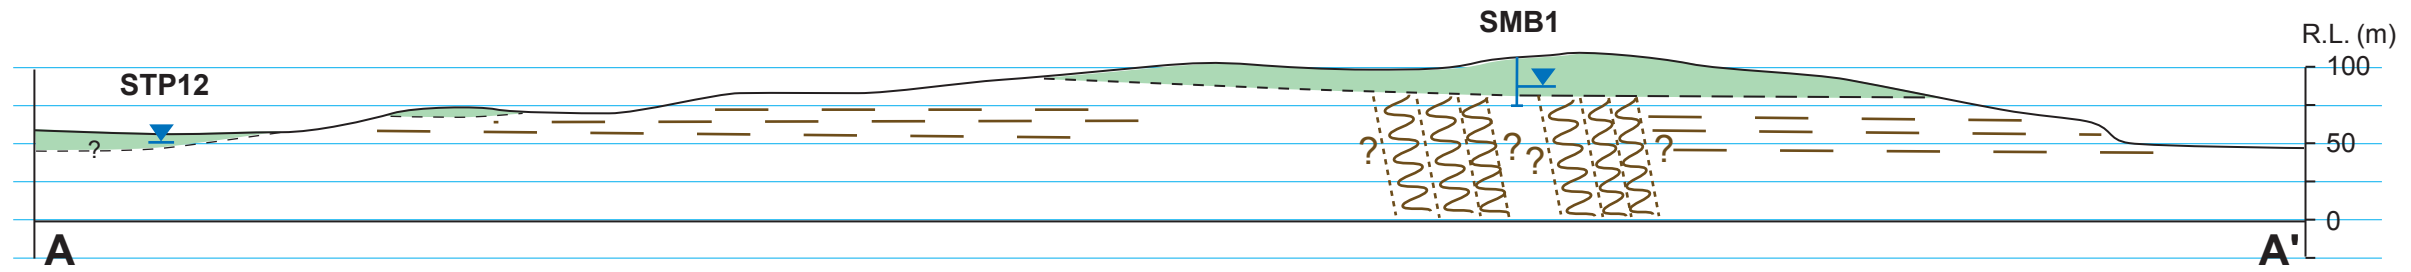
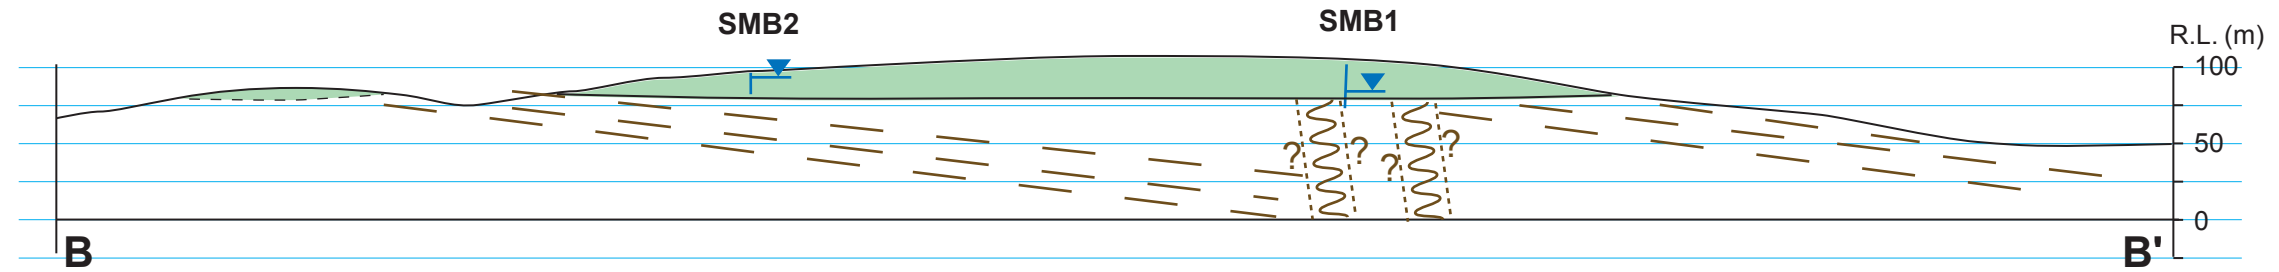
The information on sub surface conditions inferred from the test pits, boreholes and mapping observations that are to be encountered in the 2 main development areas is summarised in Tables 4 and 5 below. Natural scale cross sections presented in Figures 3 and 4 depict the main geological units, observed groundwater levels and extrapolated indicative bedrock structure.

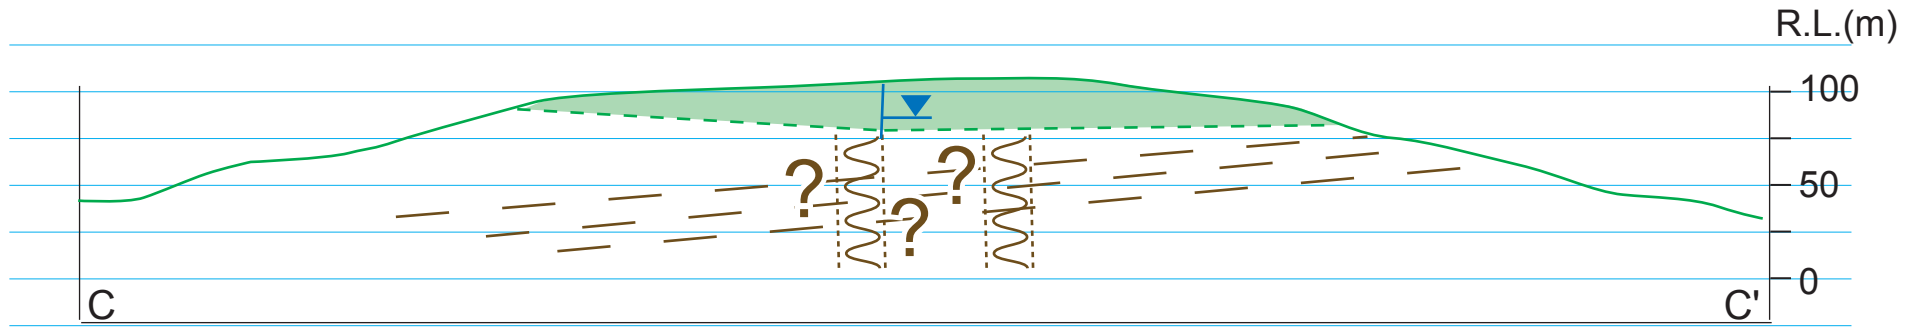
Poor Rock In Borehole
possible Shear Zone
